AMMANN AND WHITNEY NEW YORK
BLAST CAPACITY EVALUATION OF BELOWGROUND STRUCTURES. (U)

CONTRACTOR REPORT ARLCD-CR-77006

BLAST CAPACITY EVALUATION OF
BELOWGROUND STRUCTURES

MAY 1977

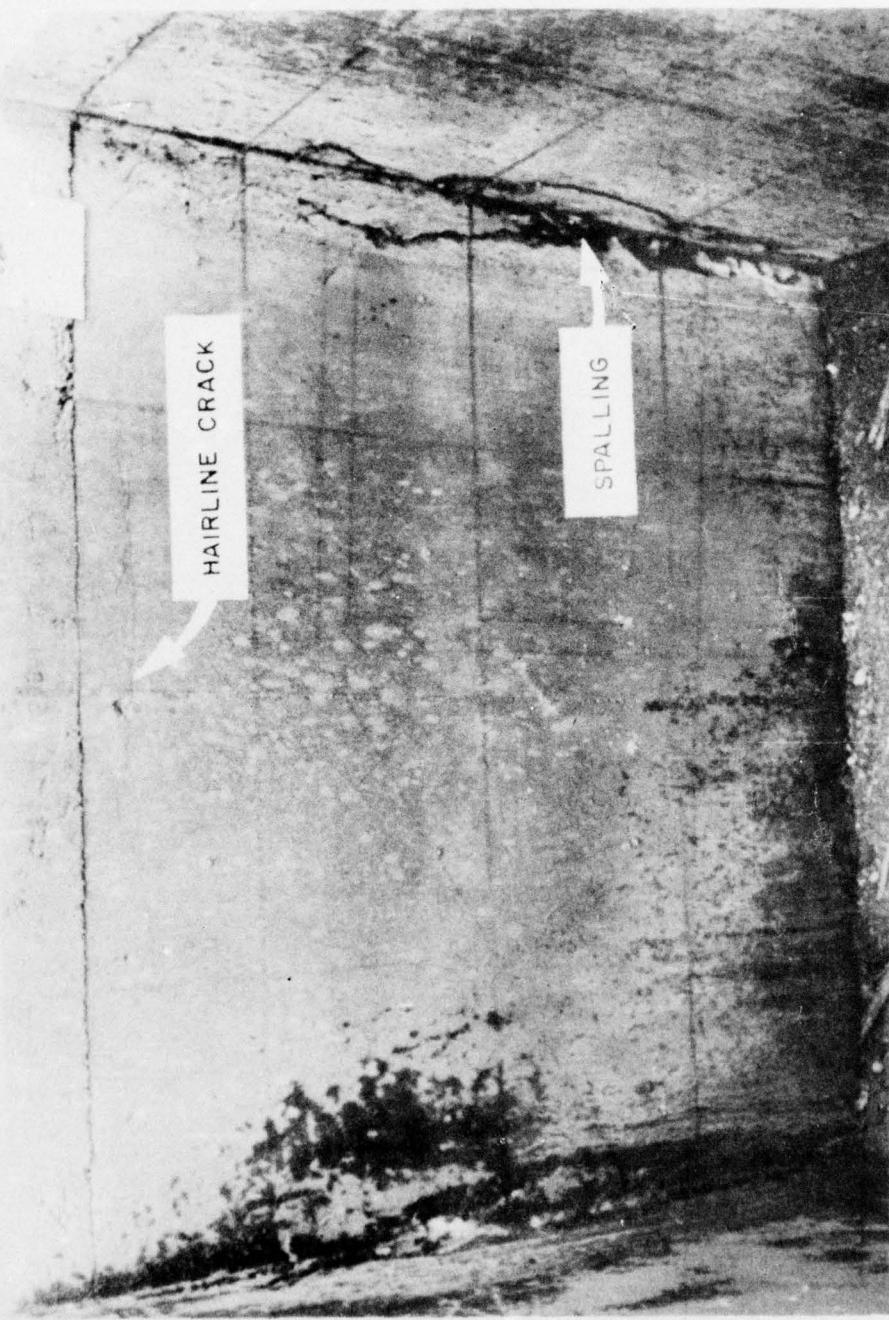
Fig 13 Post-test damage to Cell No. 1 east wall (Test No. 4)

Spalling of concrete in corners of the cell observed in Test No. 3 was appreciably increased and extended over the lower three-fourths of the cell height. Depth of spall was as large as 19 mm (3/4 in.) with some reinforcing bars in the corners visible. Cracks appeared along the intersection of floor slab and all four walls. Approximately 0.3 m (1 ft) below the top of the walls, horizontal hairline cracks were formed. These cracks were formed by the yielding of vertical reinforcement at the interface of the walls which, in turn, was produced by the blast loads acting on the top of the aprons. Hairline cracks were formed in the floor slab which radiated from its center. All this damage is illustrated in Figure 13.

The above described damage indicated that walls were being pushed into the soil by the blast loads and were acting as plates supported on four sides; the top support being furnished by the apron acting as a series of interconnected deep beams. The apron crack pattern, as shown in Figure 12, illustrates the above-mentioned beam action of the apron. It may also be noted from Figure 12 that cracks were formed in the soil at the location of the poles indicating the soil movement has occurred. These cracks were situated at the poles because of the soil weakness produced at these locations by insertion of the poles. The significance of the cracks is the extent away from the structure to which the soil is effective in resisting the movement of the structure, i.e., the angle of friction (θ) between the structure and the supporting soil is equal to or greater than 65 degrees (Fig 14). This relatively large friction angle is in part attributed to the vertical compression forces produced by the downward motion of the concrete apron and to a lesser extent by the blast loads acting on the surface of the backfill surrounding the structure.

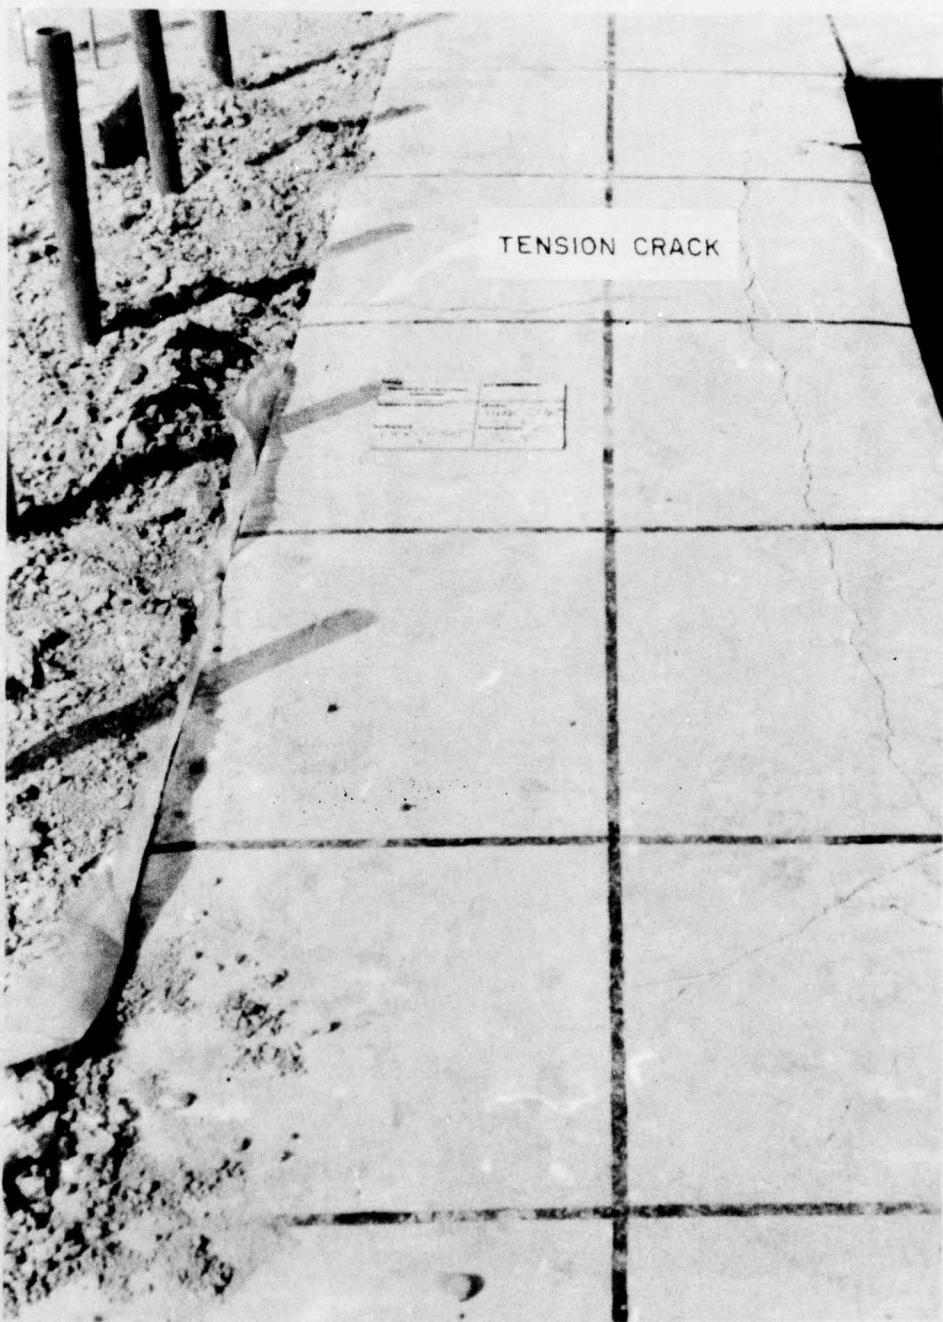
Fig 17 Post-test damage to Cell No. 1 apron (Test No. 5)

The general crack pattern of the apron in this test remained the same as that of Test No. 4. However, the cracks did widen a bit and a few new cracks around the outside corners of the apron were formed (Fig 17).

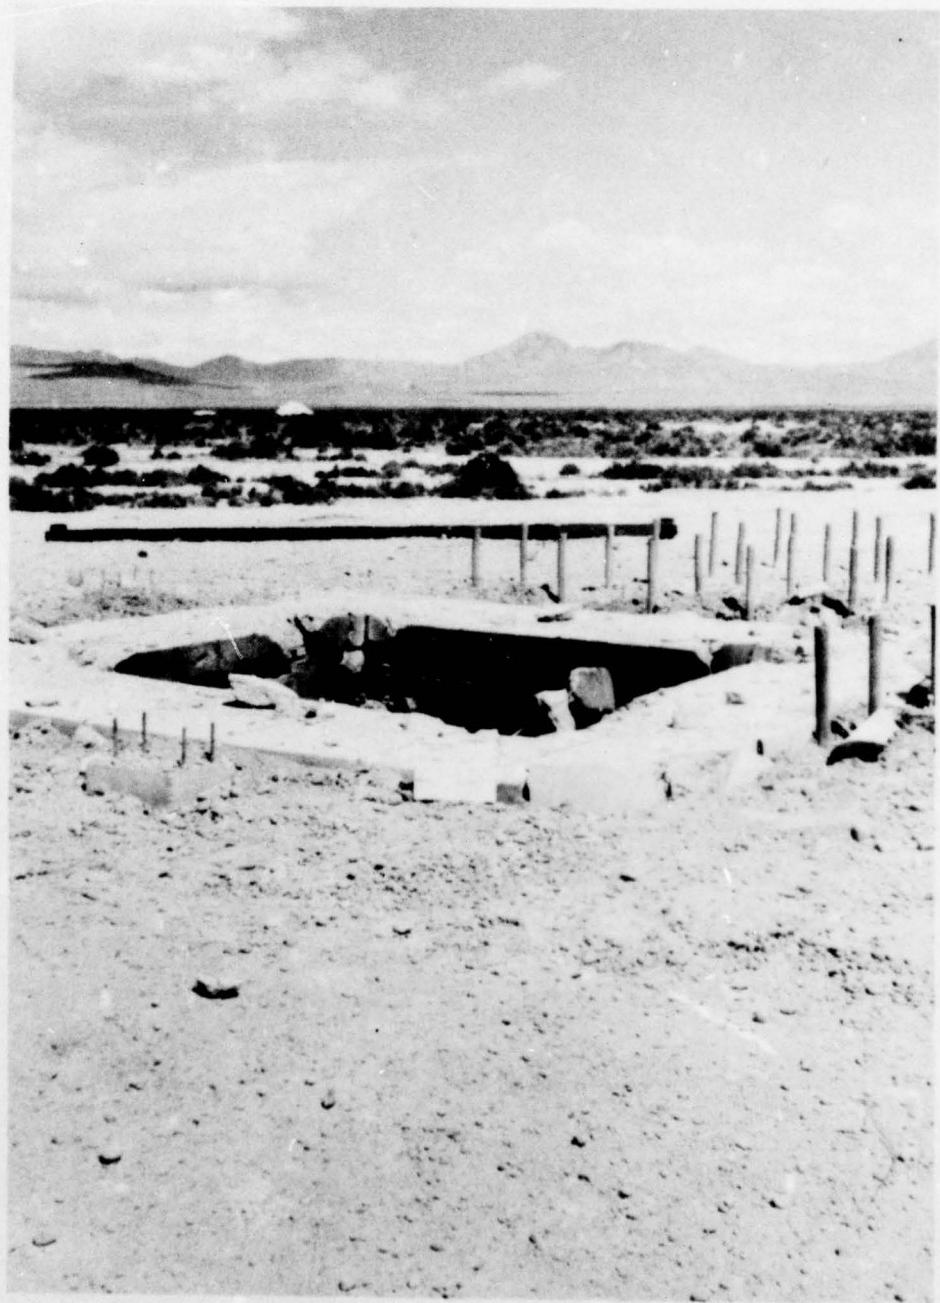
Fig 21 Post-test exterior view of Cell No. 1 (Test No. 7)

Figure 21 illustrates the overall view of the damage to the cell including debris from the breakup of the wall and apron after Test No. 7. Damage to the walls and apron is illustrated in Figure 22. Most of the debris was formed from the breakup of the wall corners. All reinforcing bars at the corners were exposed for a wall length of 0.2 m (8 in.). Some of the earth-fill fell into the cell from behind the corners (Fig 23). Permanent deflections of walls into the soil were as large as 0.2 m (8 in.) and with uniform curvatures of the walls clearly visible. This uniform curvature is attributed to the support provided by the soil over the full length and height of the walls and again is evidence of the increased resistance of the walls provided by the earth-fill.

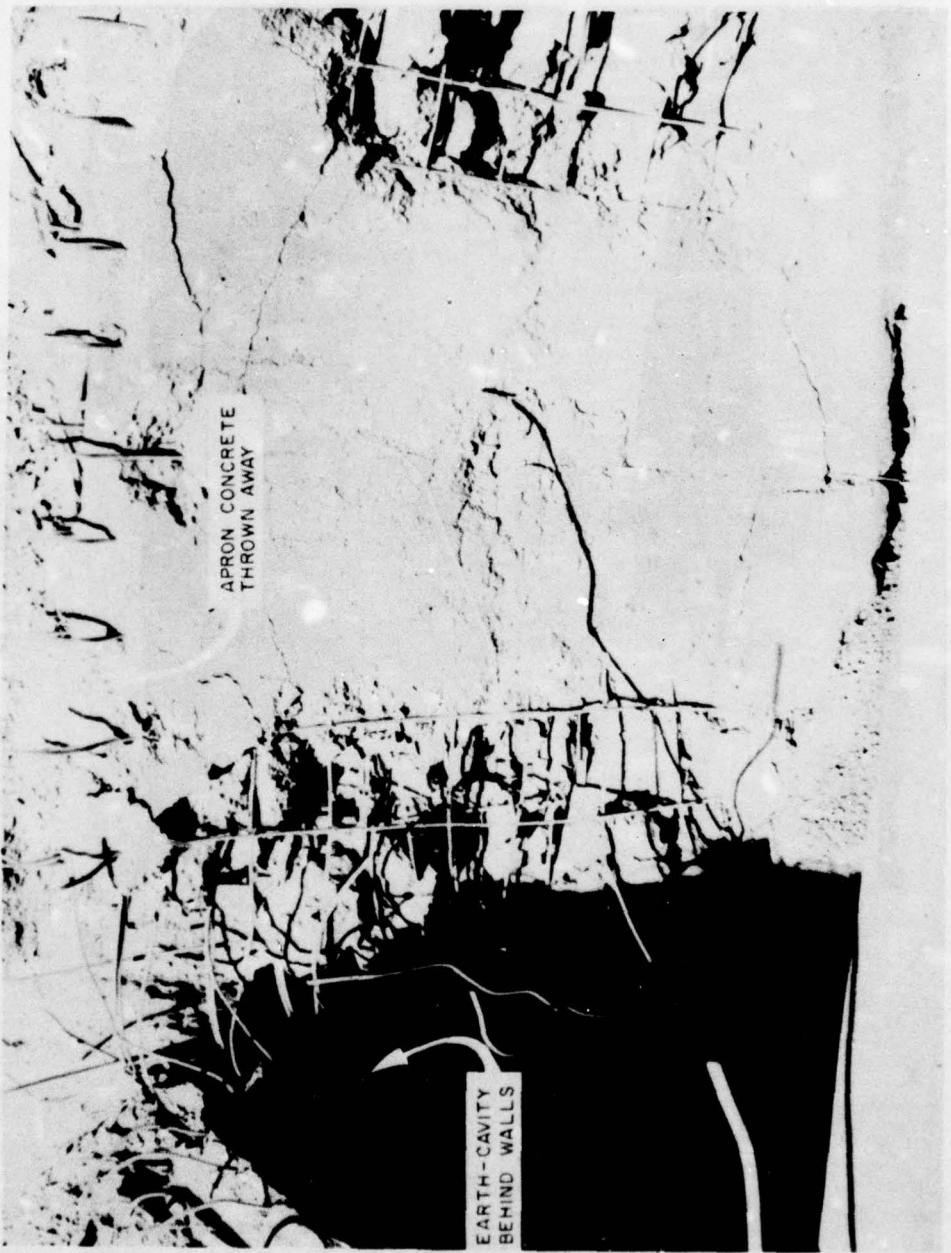
Fig 31 Post-test damage to Cell No. 1 north wall
(Test No. 9)

The added damage to the structure consisted of an increase in the removal of the concrete located at the four corners of the walls and near the intersection of the walls and floor slab, increase in the displacement of each wall panel into the earth-fill, additional cracking of the walls and the disengagement of the top of the wall which originally was part of the apron which was not removed prior to the test (Fig 31).

In general, it may be said that complete failure did not occur and that the structure functioned as an effective barricade, although some fragments were produced.

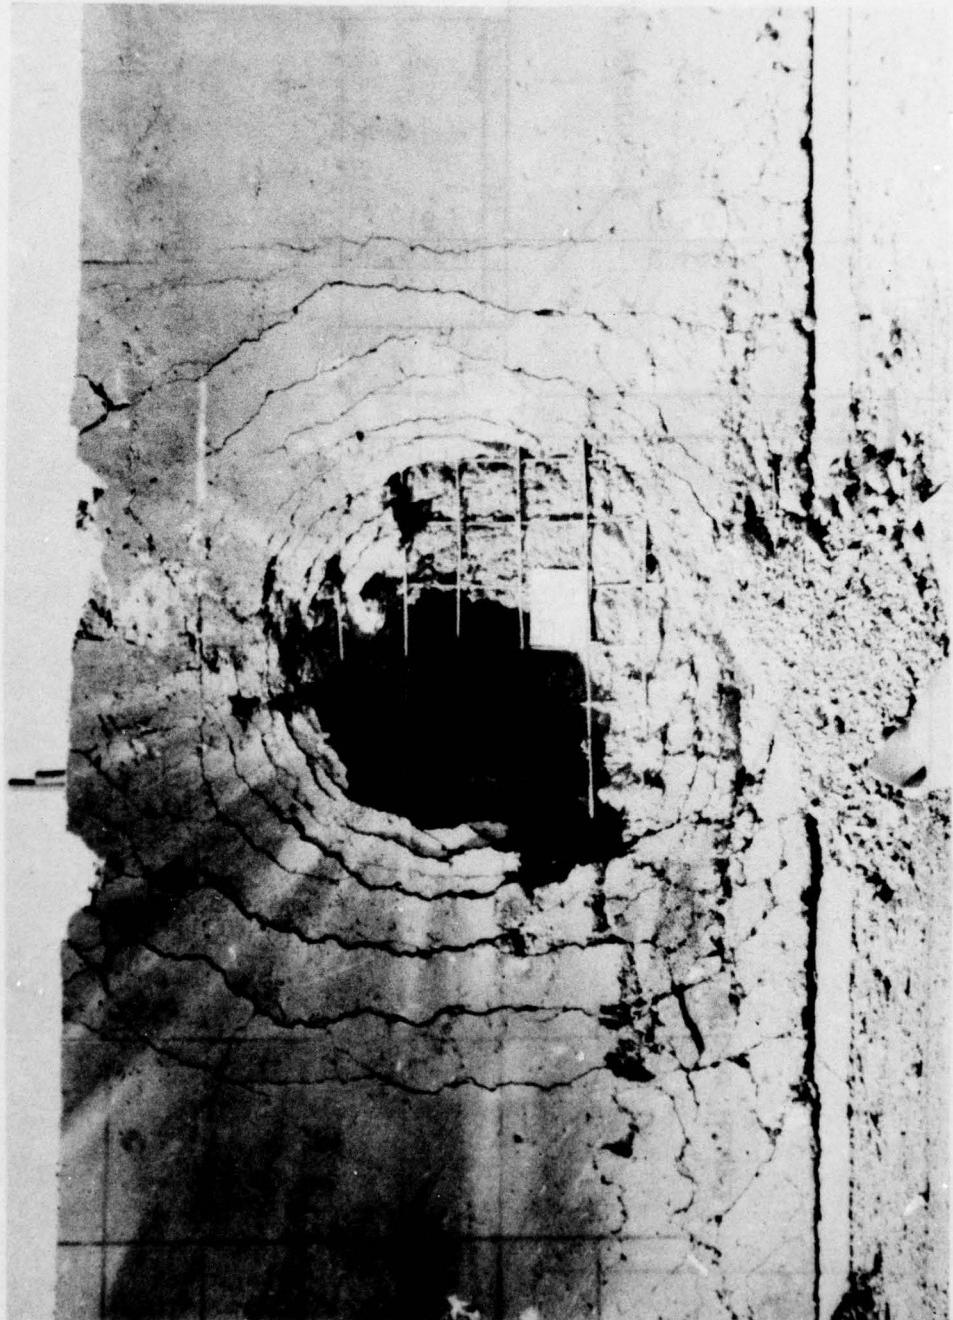
Figures 64 and 65 illustrate the damage to the two walls at the completion of the test series. Wall No. 1 sustained severe damage but still remained intact while Wall No. 2 was considered to have failed. In case of the first wall, the rebound afforded by the soil during each test was significant and thereby limited the magnitude of the permanent deflections of the wall after each test. That is to say, the sum of the permanent displacements obtained from the individual tests was less than that would have been produced by the combined weight of explosive of 204 kg. In the case of Wall No. 2, however, the initial velocity of the wall produced by the explosive output was of sufficient magnitude to overpower the resisting capacity of the system (concrete and soil), and thereby produced soil displacements large enough to make the wall fail.

Fig 64 Post-explosion view of Wall No. 1 - Barricade Tests
